Honokowai Water Quality Management Plan

June 2016

Prepared for:
NOAA Coral Reef Conservation Program

Prepared by:
Horsley Witten Group, Inc.

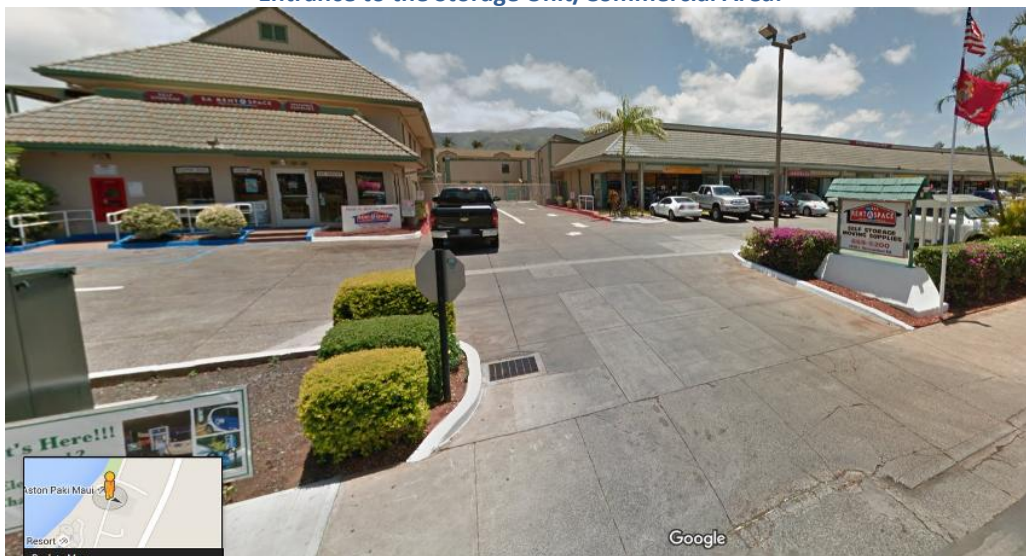
This commercial property was developed in 1987, and the majority of the property is comprised of storage units and associated parking area. The rest of the property consists of small stores and restaurants and their parking. The entire drainage network at this site was not observed since we did not gain access to the storage unit area, but the catch basin at the entrance was opened, and it was confirmed that this area contributes drainage to HBP-3. This property has the highest impervious cover in the watershed at over 90%, yet there does not appear to be any stormwater management on site.

Entrance to the Storage Unit/Commercial Area.

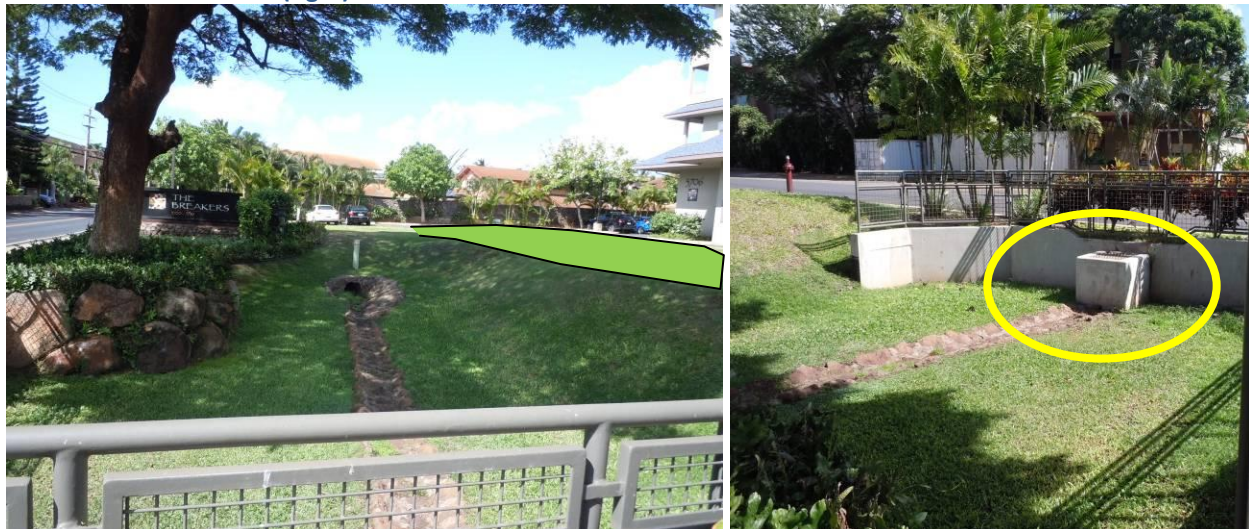
The Breakers is the newest development in the watershed (2008) and has the only observed stormwater BMP – an extended detention basin. There is a total of 2 acres of impervious cover that contributes runoff to the small basin immediately adjacent to Lower Honoapiilani Rd. This includes almost 1 acre of roof top that is directly connected to the parking area via downspouts discharging to the pavement. Runoff is collected by a series of catch basins and directed into the detention basin. Low flows are conveyed with a hardened (appears to be a mortared rock base) low-flow channel with little to no detention before flowing out the orifice in the overflow structure. Runoff from larger storm events will be detained in the basin until the water reaches the top of the overflow structure, where it will flow through the grate and into the storm drain system in the road. The proposed retrofit for this site is to enlarge the existing basin utilizing the open lawn next to the basin (currently slated for future development), providing water quality treatment features such as a sediment forebay for pretreatment, longer flow path for low flows, wetland vegetation to filter and take up nutrients, and greater flood storage for larger events. In addition, the rooftop runoff should be collected in cisterns and reused as much as possible. Allowing the clean roof runoff to flow over a parking lot, picking up all the associated pollutants, is a lost opportunity. This could also provide a good example for other developments in the watershed – almost all buildings have gutters and downspouts for roof runoff, and yet no cisterns or rain barrels were observed. This project does have potential for public education given its location next to the main road, but it is a private development where future buildings are proposed, presenting an implementation challenge.

Looking down the low-flow channel in The Breakers existing detention basin with the proposed basin expansion indicated in green (left); overflow structure for the detention basin showing a low-flow orifice at the same elevation as the channel (right).

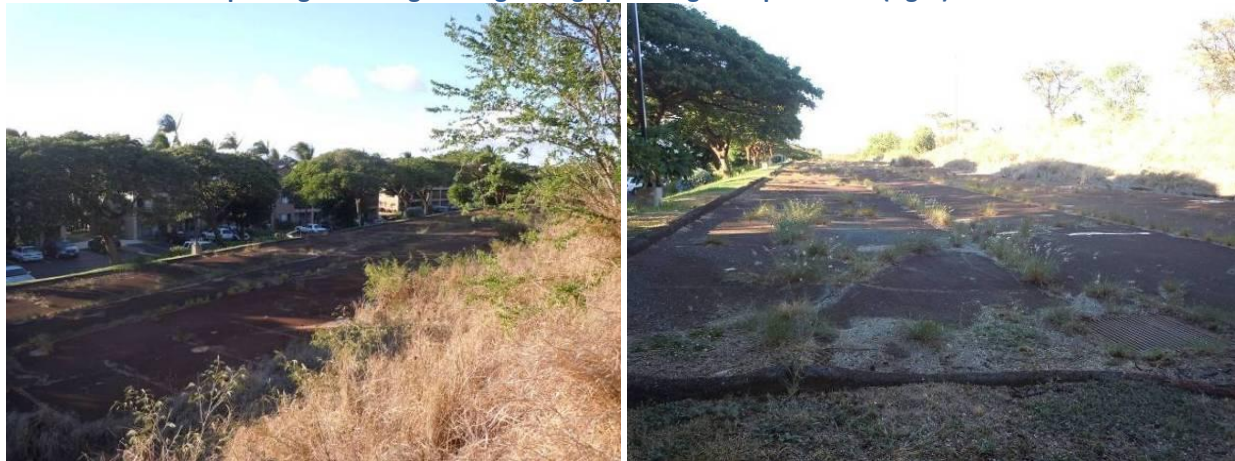
This 3.8-acre property is located at the top of the watershed next to the Honoapiilani Highway. Much of the site is pervious, except for a 0.9-acre abandoned parking lot. This parking lot is not completely impervious with many cracks where vegetation has started growing. However, we assume that it still creates runoff during larger storm events, adding to downstream flooding and water quality issues. This property presents a great opportunity to revegetate in a highly urbanized, impervious watershed. This area could also be converted into a park with walking paths and picnic tables for the many nearby residents of Sunset Terrace, Honokowai East, West Maui Trades, The Breakers, and more. Pavement removal and revegetation is relatively inexpensive compared to other stormwater retrofit opportunities in the watershed; however, the State ownership of this property could present a challenge if the land is slated for a different purpose. That being said, the State could also be a great partner in this and other projects in the watershed.

Looking down at the abandoned parking lot from the shoulder of Honoapiilani Highway (left); many cracks are visible in the former parking lot with grasses growing up through the pavement (right).

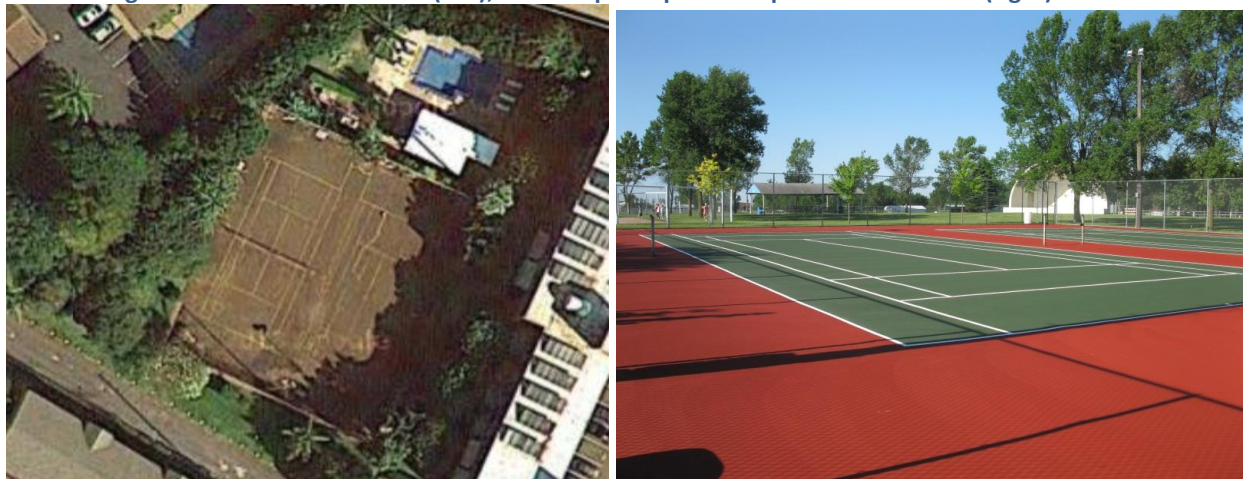
R-6: Honokowai East – Pavement Removal/Permeable Tennis Courts

This condominium complex has tennis courts for its residents to use. The courts are impervious (~12,000 sf) and in need of repair/repaving. The impervious surface could be replaced with a permeable material such as permeable asphalt, porous concrete, or a more flexible permeable surface made of recycled rubber. This type of material could also be used at the other tennis courts in the study area – Hale Royale. While this proposed retrofit would manage runoff from over 20% of the Honokowai East property, it is located on private property and presents little opportunity for public education other than for the condominium residents.

The existing courts at Honokowai East (left); an example of porous asphalt tennis courts (right).

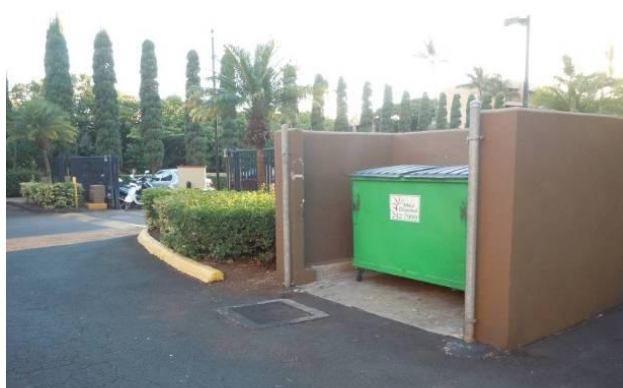
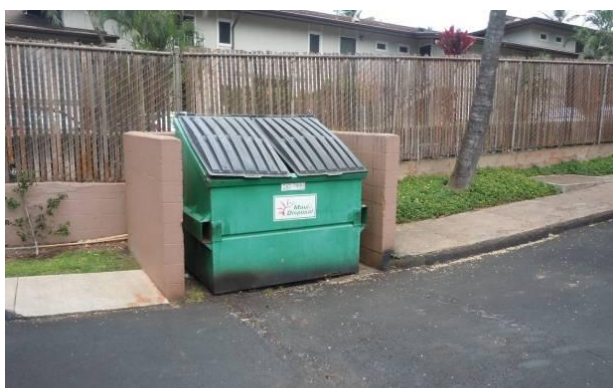
All of the dumpsters for this large complex (Hale Royale) are located right next to this catchbasin. The dumpsters do have lids, but there is still a risk of “dumpster juice” leaking directly into the storm drain.

Another dumpster located right next to a catch basin at Sunset Terrace (left). This dumpster at Maui Lani Terraces is actually placed directly on top of a catch basin (right).

- Improved dumpster management—Covers reduce the amount of direct rainfall onto materials and secondary containment provides a barrier to leaking containers. Most dumpsters in the watershed did have covers, but almost all of them were located right next to catch basins. Moving dumpsters away from catch basins is a relatively inexpensive solution.

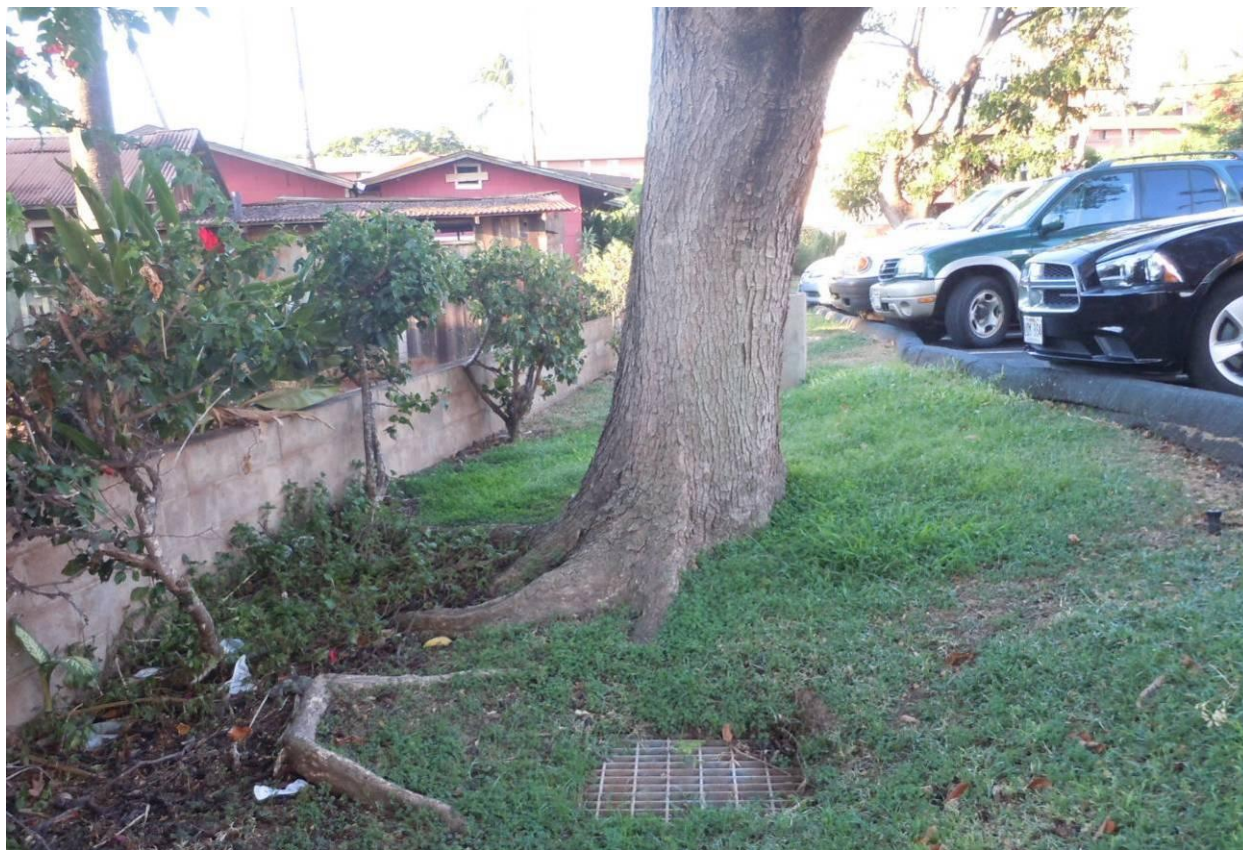
This catch basin is located in the landscaping area at Sunset Terrace near the back of the Farmer's Market Plaza. Flat grates like this one are easily clogged by vegetative debris, which can lead to flooding issues as well as adding more nutrients to the stormwater system.

- Proper landscape management—Homeowners and property managers should reduce the amount of fertilizers, spray irrigation, pesticides, or other chemicals applied to turf and landscaping. Landscaping debris should be kept out of the storm drain, and pet waste should be picked up in areas where dogs are frequently walked.

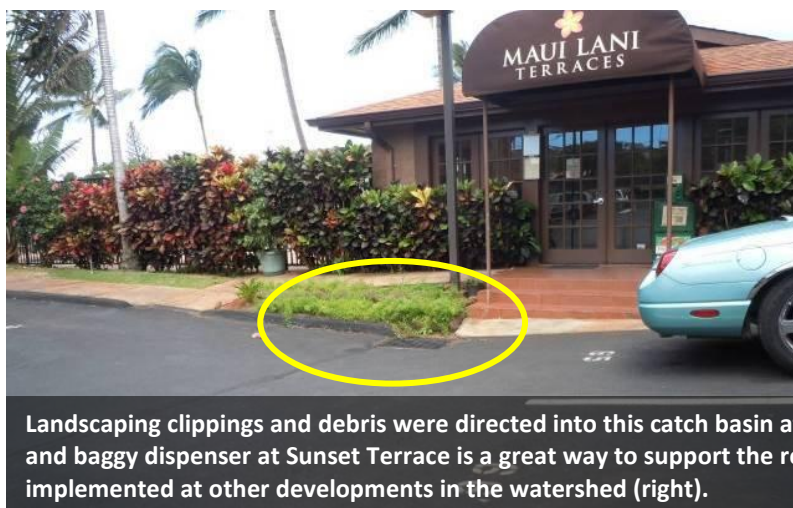
Landscaping clippings and debris were directed into this catch basin at Maui Lani Terraces (left). This sign and baggy dispenser at Sunset Terrace is a great way to support the removal of pet waste and should be implemented at other developments in the watershed (right).

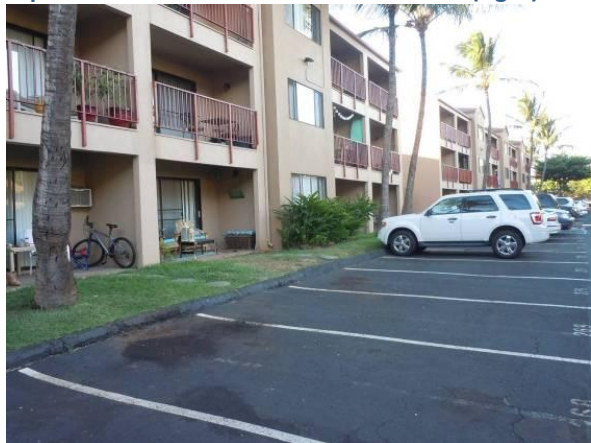
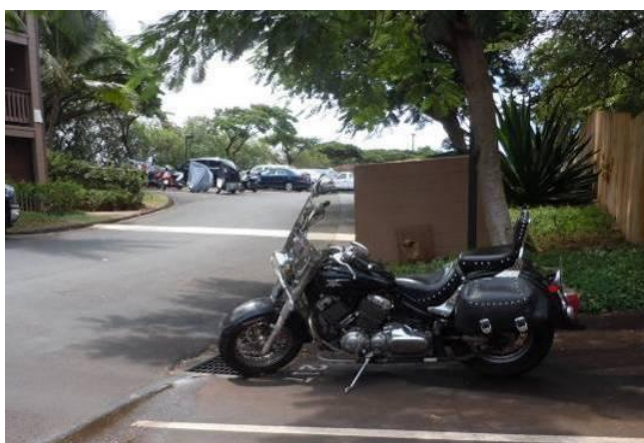
Oil stains are visible on the parking lot near a catch basin at Sunset Terrace (left); a motorcycle is being stored on top of a catch basin at Maui Lani Terraces (right).

- **Vehicle Maintenance** — Many of the residential developments had areas in the parking lots where vehicles (cars, boats, motorcycles, etc.) were being stored and/or maintained. Drippings from vehicles then flow into the storm drain. Residents should be encouraged to either take their vehicles to a shop for maintenance, or perform oil changes and other activities in an area far from a storm drain and properly clean up and dispose of supplies.
